**TEST REPORT**

NUMBER: TWNH00010932

ITEM NAME : GVLX-4C2

STANDARD  
VIBRATION TEST  
— WITH REFERENCE TO  
IEC60068-2-34 TEST Fd

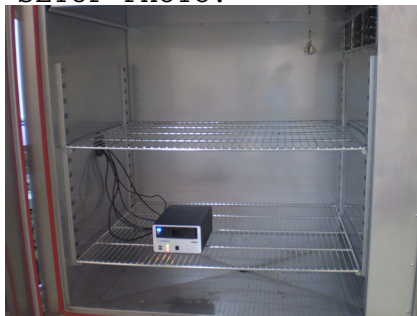
SET 01

EQUIPMENT : TEMPERATURE & HUMIDITY CHAMBER  
 MANUFACTURER : KSON  
 MODEL NUMBER : THS-D4S-100  
 DATE OF CALIBRATION : NOV. 28, 2007

-SAMPLE SIZE: 1 UNIT  
 -SETUP PHOTO:

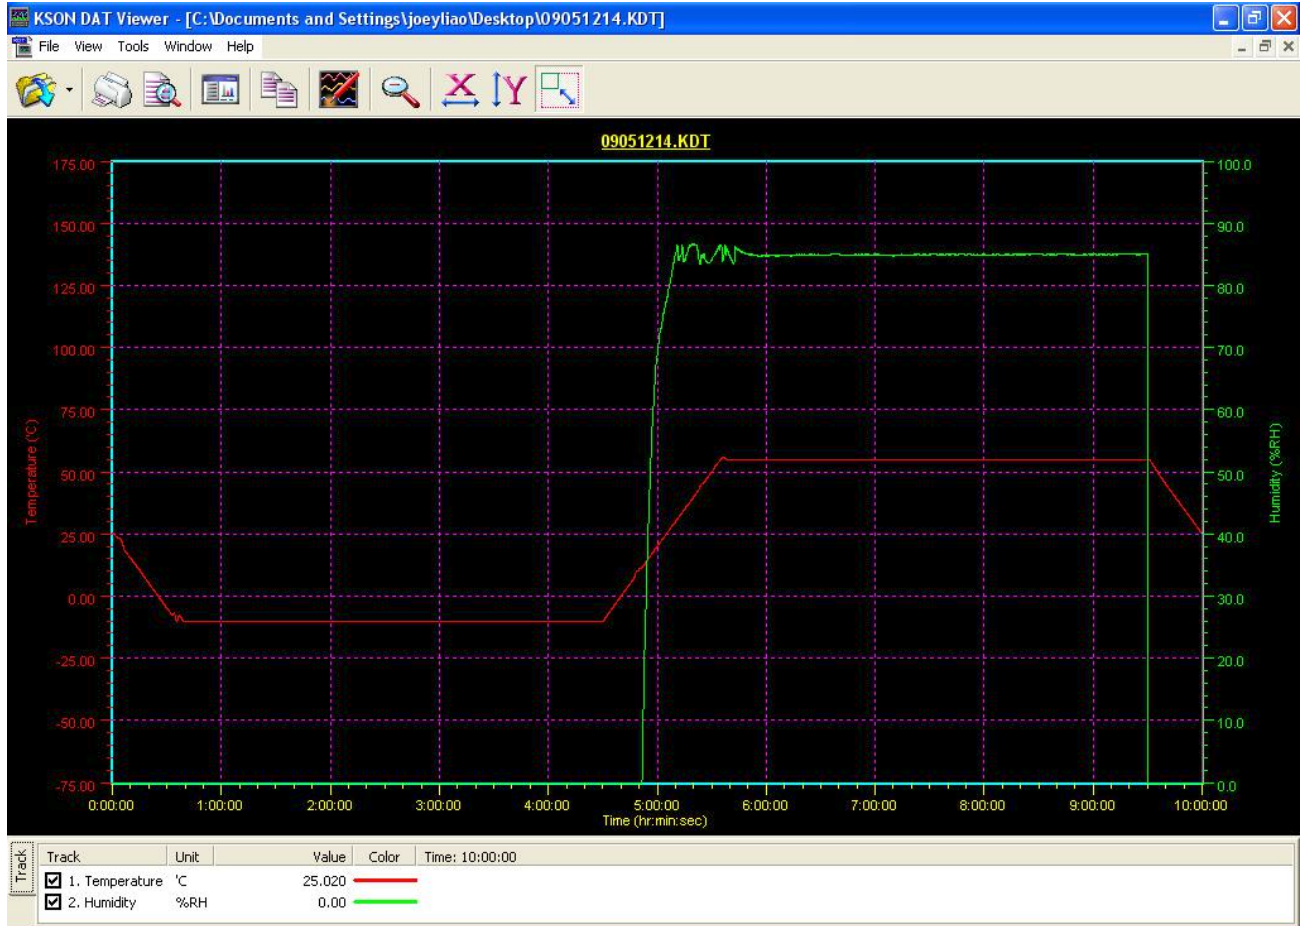
-TEST PROFILE:

TEST STEP	TEMPERATURE (°C)	HUMIDITY (%RH)	DURATION (MINUTE)
1	25 TO -10	0	35
2	-10	0	235
3	-10 TO 55	0 TO 85	65
4	55	85	235
5	55 TO 25	85 TO 0	30
