**TEST REPORT**

NUMBER : TWNH00011461

ONE (1) UNIT OF SUBMITTED SAMPLE SAID TO BE :  
ITEM NAME : COMPACTDVR V2  
ITEM NO. : GVLX4C2  
QUANTITY : 1 UNIT  
DATE SAMPLE RECEIVED : OCT 17, 2008  
DATE TEST STARTED : OCT 20, 2008

**MECHANICAL SHOCK TEST**

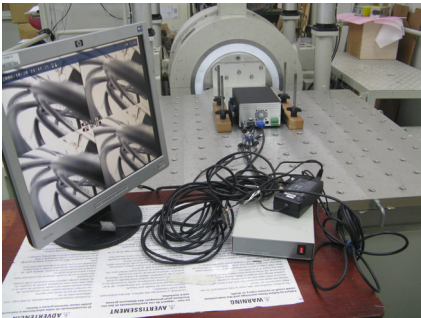
X AXIS

- SAMPLE SIZE: 1 UNIT
- SETUP PHOTO:
