**Test Report**

Number : TWNH00021902

Item Name : (A) Compact DVR 8 CH 1Bays Anti Vibration  
(B) Compact DVR 8 CH 2Bays Anti Vibration  
Item No. : (A) GV-LX8CV1  
(B) GV-LX8CV2

The test was performed with reference to IEC60068-2-27 test Ea.

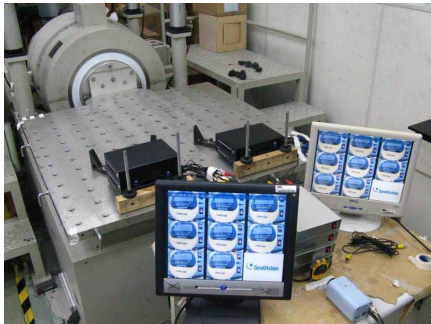
±Y Axis

- Sample Size: 2 units
- Setup Photo:

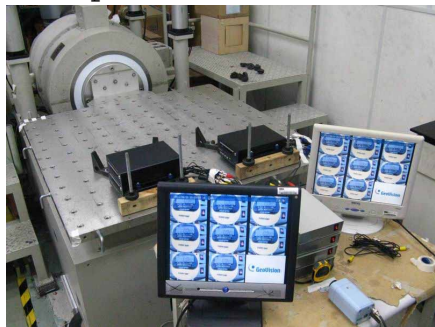
Y Axis

- Sample Size: 2 units
- Setup Photo:
