Report No.: HC10278/2013

<u>Product Description:</u> Megapixel H. 264 WDR (3x zoom) IR Bullet IP Camera

Style/ Item No.: GV-BL1210/ No.1

1. Impact Test

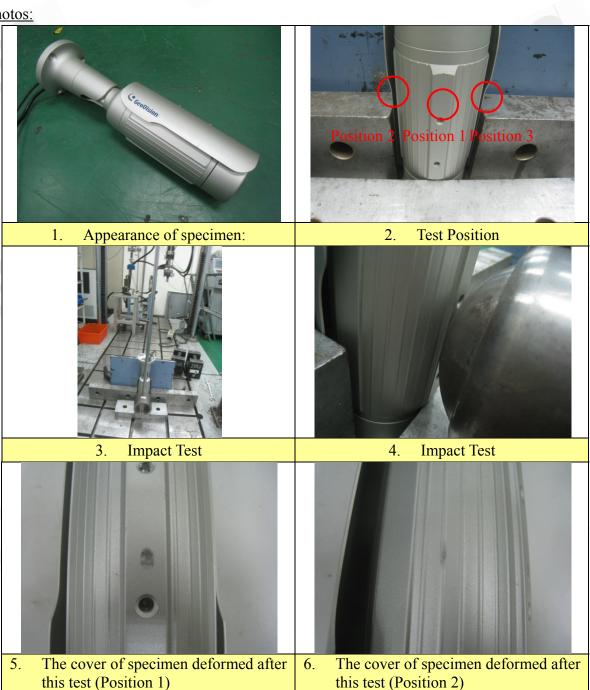
### **Test Photos:**

Test Position: Position 1 ~ Position 3 (see photo 2)

Testing device: As shown in photo 3, 4

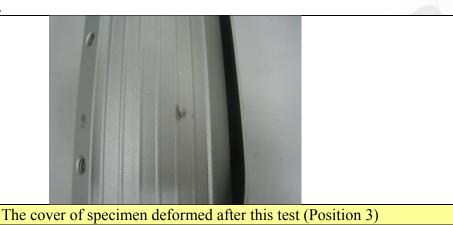
**Test Photos--Continued:**

Check Item	Appearance check
Style/ Item No.		(visual check)
GV-BL1210/ No.1	Position 1	The cover of specimen deformed after this test.
		(See photo 5)
	Position 2	The cover of specimen deformed after this test.
		(See photo 6)
	Position 3	The cover of specimen deformed after this test.
		(See photo 7)
