TEST REPORT

Report No.: HC10170/2013 Page: 1 of 5 February 7, 2013 Date:

The following merchandise was submitted and identified by the vendor as: Product Description: Megapixel H. 264 WDR Arctic Box IP Camera GV-BX1500-E/ No.1 Style/ Item No.: Manufacturer/Vendor: Geovision Inc. Country of Origin: Taiwan Quantity: Total 1 piece Jan. 30, 2013 **Testing Period**: (Client's declaration) The GV-BX2400-E, GV-BX3400-E, GV-BX5300-E, Note: GV-LPR CAM 10A and GV-Hybrid LPR Camera 10R used the identical enclosure.

1. Impact Test

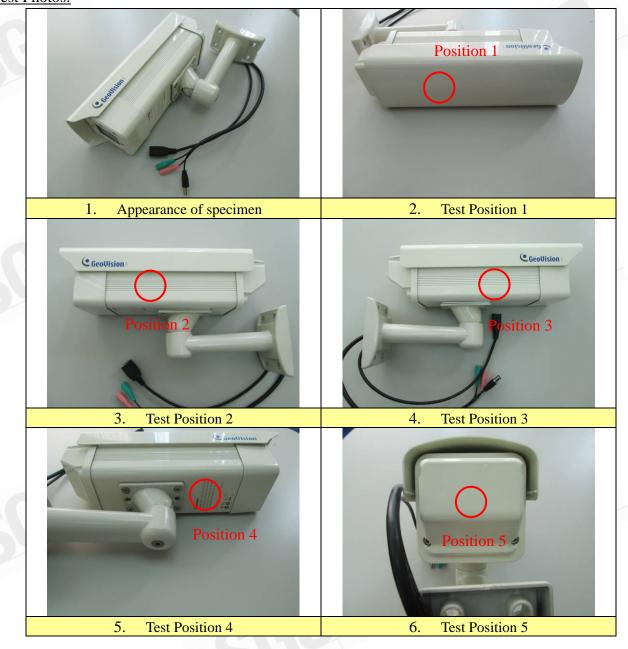
Test Photos:

Name	Brand	Model	Serial No.
Impact Tester	CHUN YEN	-	
Lab Environmental Cond	itions:		
Ambient temperature:	<u>(25 ± 3) °C</u>		
Ambient humidity:	<u>(55 ± 20) % RH</u>		
Test Method/ Specification	on:		
Test method:	Reference to IEC 62262 Edition 1.	0: 2001IK10	
Sample condition:	Non-Operating		
Sample condition: Impact energy:	<u>Non-Operating</u> 20 Joule		
Impact energy:	20 Joule		
Impact energy: Mass:	<u>20 Joule</u> <u>5 kg</u>	<u>2 ~ 6)</u>	
Impact energy: Mass: Impact height:	<u>20 Joule</u> <u>5 kg</u> <u>40 cm</u>	<u>2 ~ 6)</u>

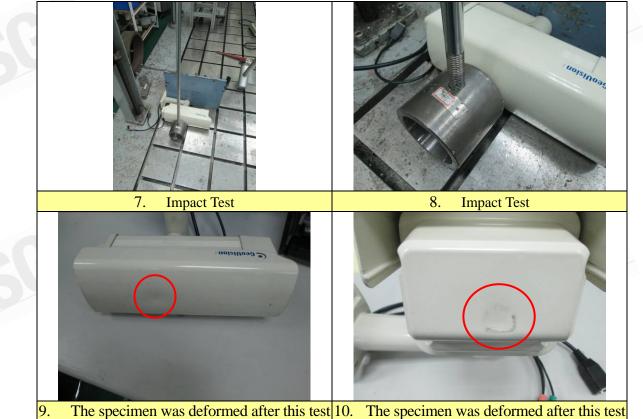
Check Item	Appearance check	
Style/ Item No.		(visual check)	
GV-BX1500-E/ No.1 Posi	Position 1	The specimen was deformed after this test. (see photo 9)	
	Position 2	No visible damage	
	Position 3	No visible damage	
	Position 4	No visible damage	
	Position 5	The specimen was deformed after this test. (see photo 10)
